# Manhole Inspection Summary

# Manhole # S11AA2018MH

Insp Date: **9/27/06 1:12 PM**

**Location** Address: **5727 GREENSPRING AVE**

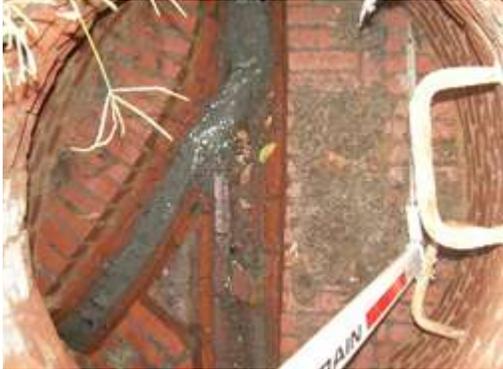
Top View

Corroded steps. Bench debris.

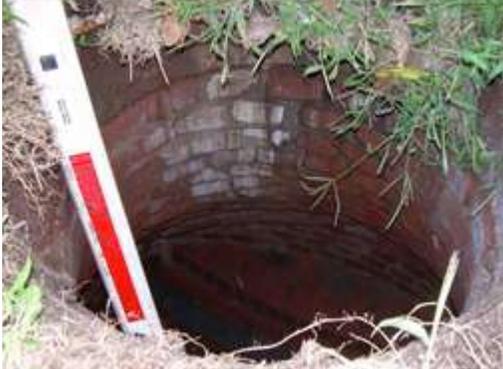
Defect

Adjustment deterioration and infiltration.  
Corbel and Barrel infiltration.

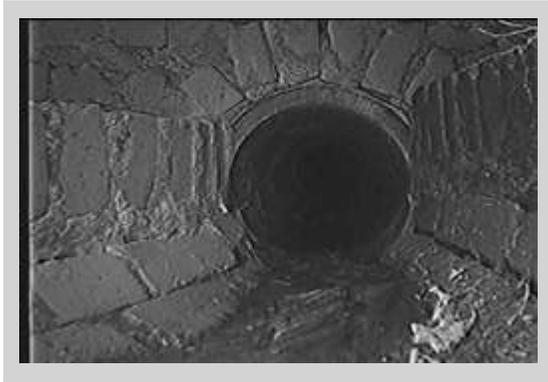
**10 in. Circular Gravity Sewer  
Pipe Out @ 12 O'Clock**

Invert Depth: **6.15** (ft.) Flow Characteristics: **Slow**

Infiltration: **Evidence** Pipe Seal Cond: **Cracked**

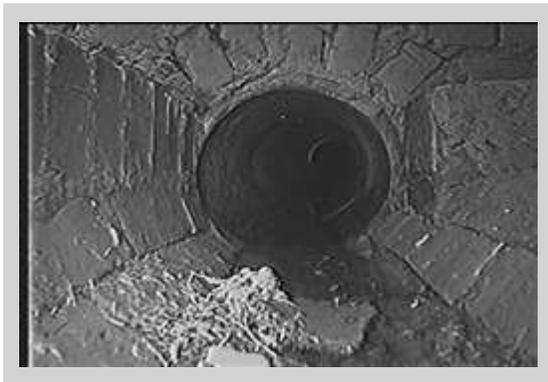
**10 in. Circular Gravity Sewer  
Pipe In @ 6 O'Clock**

Invert Depth: **6.07** (ft.) Flow Characteristics: **Slow**

Infiltration: **Evidence** Pipe Seal Cond: **Cracked**

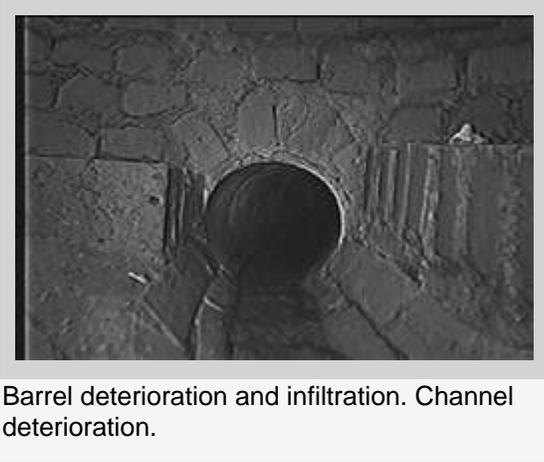
Pipe In @ 8 O'Clock

Barrel deterioration and infiltration. Channel deterioration.

Infiltration: **Evidence** Pipe Seal Cond: **Unknown**
